Research and Development Technical Report  
DELNV-76-0261-F

# LOW VOLTAGE IGNITION SEALED BEAM XENON LAMP

ITT Electron Tube Division  
3100 Charlotte Avenue  
Easton, Pennsylvania 18042

1 November 1979

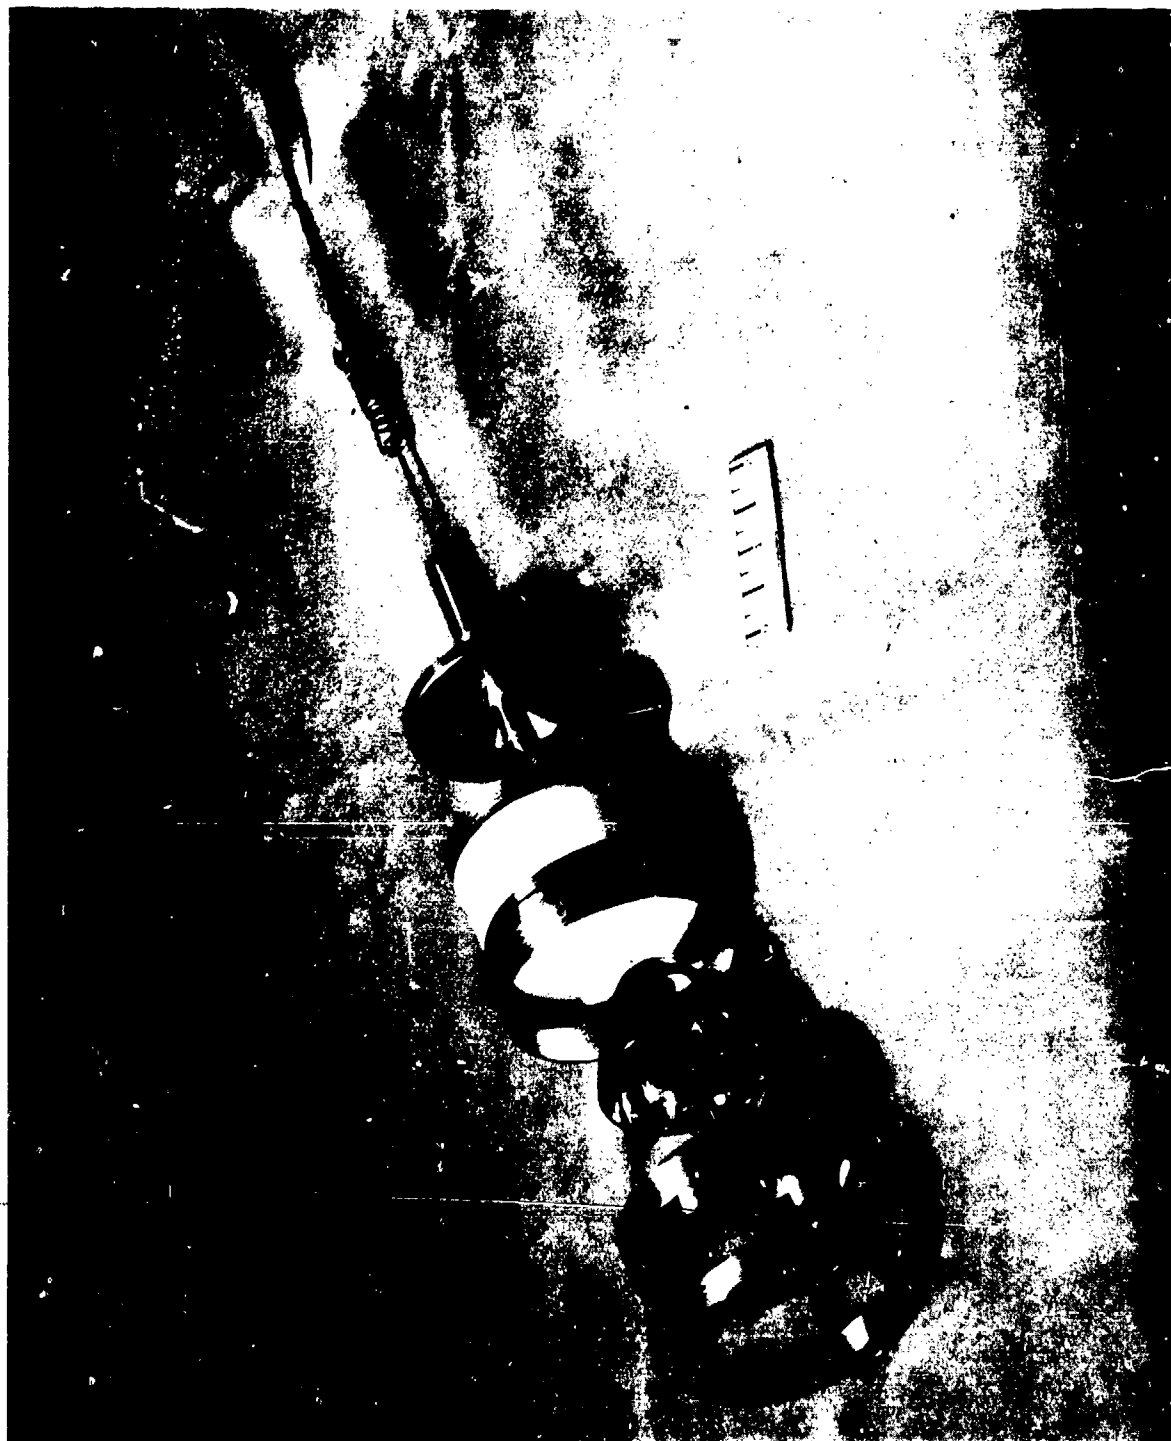
FIGURE 7.

EXPLODED VIEW - ITT LOW VOLTAGE START XENON LAMP

Figure 7 shows an exploded view of the lamp with the backplate and striker rod in the upper right hand portion. Figure 8 shows the assembled lamp with the striker housing to the right.

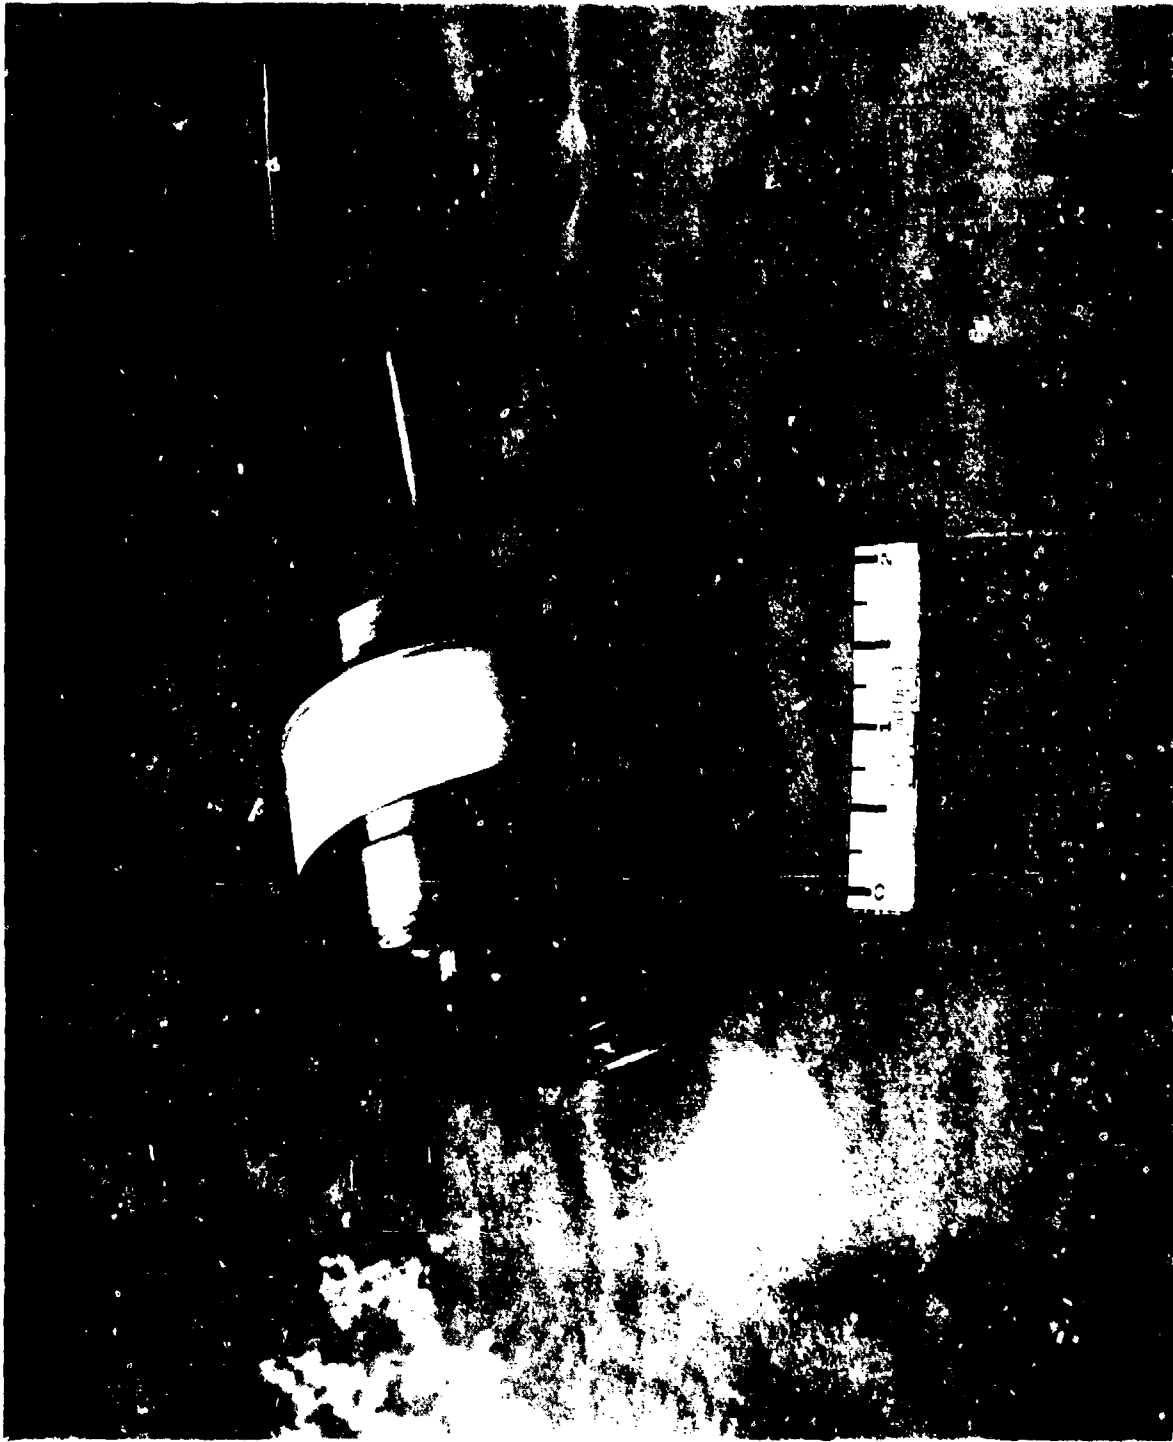
FIGURE 8.

ITT LOW VOLTAGE START XENON LAMP

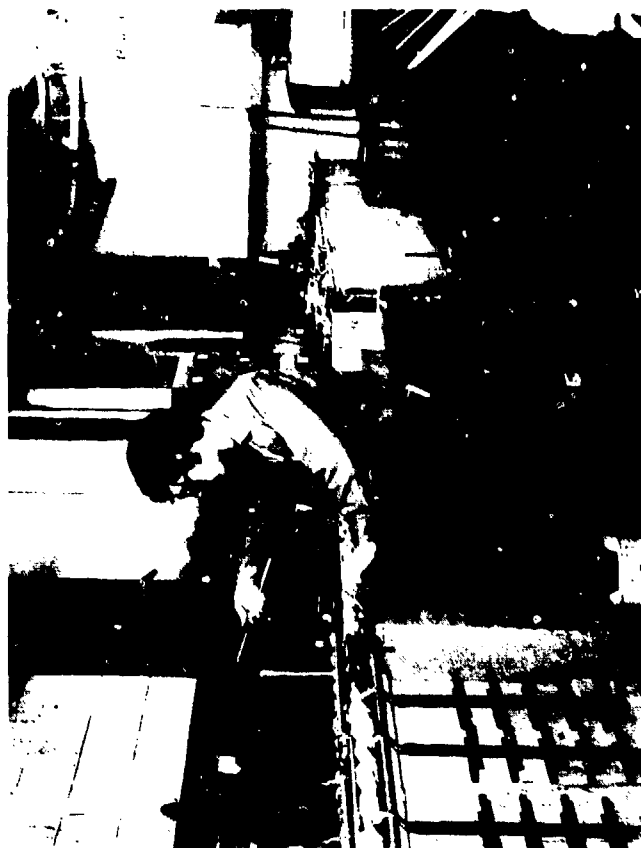
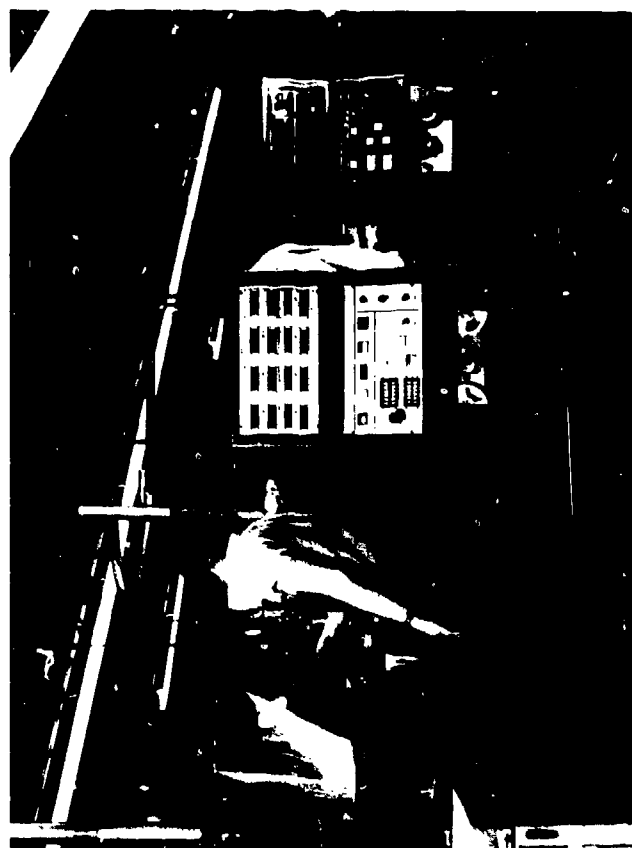
PROTOTYPE REFLECTOR FABRICATION SET-UP

ITT-ETD PRODUCTION REFLECTOR FABRICATOR FACILITIES

SEALED BEAM REFLECTOR TEST EQUIPMENT

ITT-ETD NUMERICALLY CONTROLLED LATHES

The reflector was redesigned using conventional design techniques. The design was based on the use of a classical ellipsoid. Figure 9 shows various operations involved in the design and fabrication of the reflector.

The mandrel required for electroforming the reflector was generated by the use of a numerical controlled lathe, shown in Figure 9. The reflector consists of a nickel substrate and a silver plated reflecting surface. ITT developed the techniques required to fabricate the reflectors. After the design of the reflector had been finalized, ITT investigated the use of outside vendors to reduce production costs. ITT fabricated and provided mandrels to outside vendors. Both the ITT fabricated reflectors and the vendor fabricated reflectors proved satisfactory (Figure 10).
